Smoke and Dye Testing Summary

High Level Sewershed

Run Summary

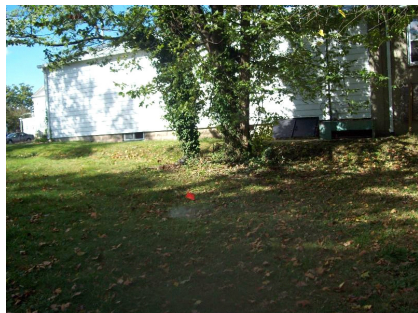
Picture \S1028-130-OB01-P01.jpg

Comments Smoke from cleanout in back yard. 2307 Garrison Blvd.

Comments Back of house, 2307 Garrison Blvd.
